JONES RIVER BASIN
ISAAC BRANCH, KENT COUNTY
DELAWARE

WYOMING LAKE DAM

DE 00034

**PHASE 1 INSPECTION REPORT
NATIONAL DAM SAFETY PROGRAM**

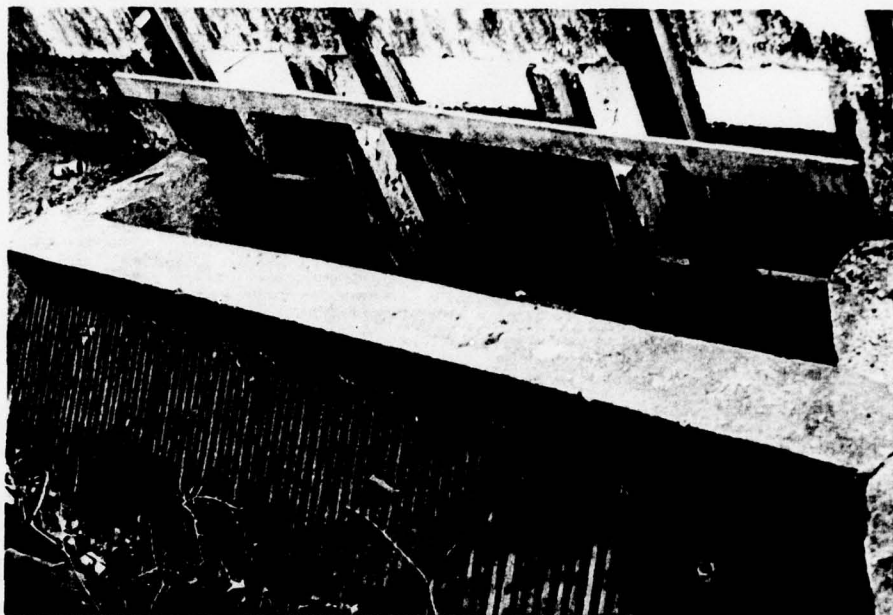
PHOTO 7
Mill Race-Lift Stems & Trash Rack

The south concrete approach wall to the Mill Race shows signs of minor concrete deterioration. The 2 to 3 foot high retaining wall on the north bank has tilted inward approximately 2 inches and stabilized. The concrete piers that support the metal storage building which spans the approach to the race shows signs of minor concrete deterioration at and below the water line. The entrance to the gates utilizes a trash rack which is presently filled with miscellaneous debris. The one inch diameter trash rack rods are badly deteriorated to approximately 1/2" diameter at the water line, and the rack is clogged with debris. The wood stoplogs are in very poor condition and may be inoperable. The Mill Race concrete culvert shows signs of minor concrete deterioration but no significant cracking was evident. The water distribution chamber upstream of the turbines is in fair condition.

d. The deteriorated trash control at the Mill Road spillway and the deteriorating trashrack at the mill raceway should be repaired or replaced within one year from the date of approval of this report.

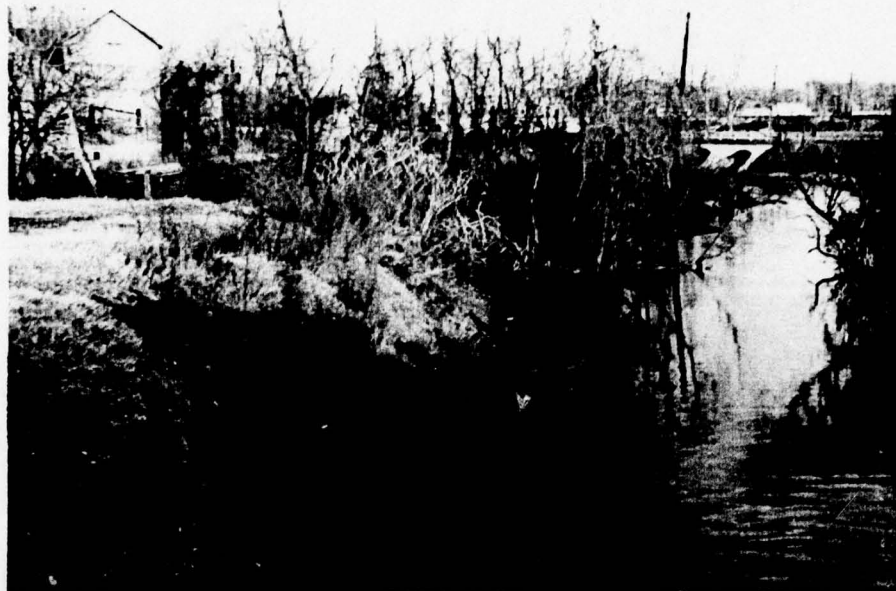
PHOTO 15

Downstream View of Eroded South-
Side - Mill Road Dam Channel

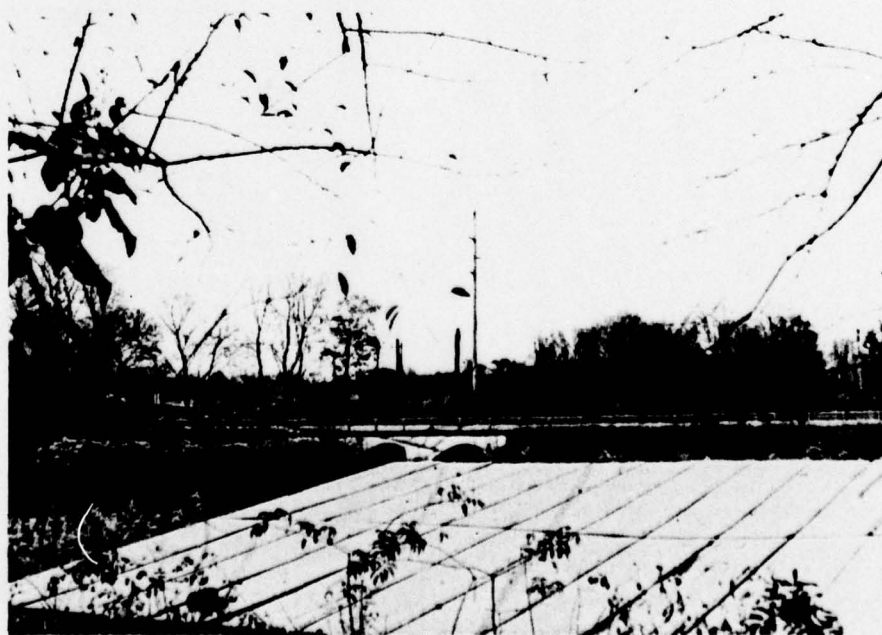
PHOTO 18
Overtop View-Route 195 and Penn.
Railroad From Mill Road

- Photo 18 - View from the center of the Mill Road showing the relative elevations of the Rt. 195 bridge and the Pennsylvania railroad line. Note that the railroad is at a considerably higher elevation than Rt. 195.
